Construction, Maintenance, and Operation of a Glacial Runway, McMurdo Station, Antarctica

George L. Blaisdell, Renee M. Lang, Gerald Crist, Keith Kurtti, R. Jeffrey Harbin, and Daniel Flora

March 1998

Monograph 98-1

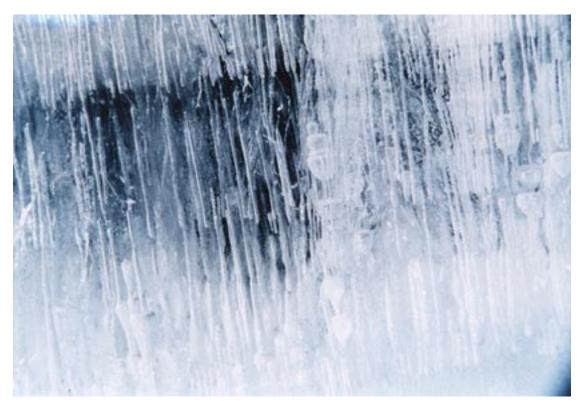
Figure 4. Example of melt/refreeze ice with cylindrical bubbles.

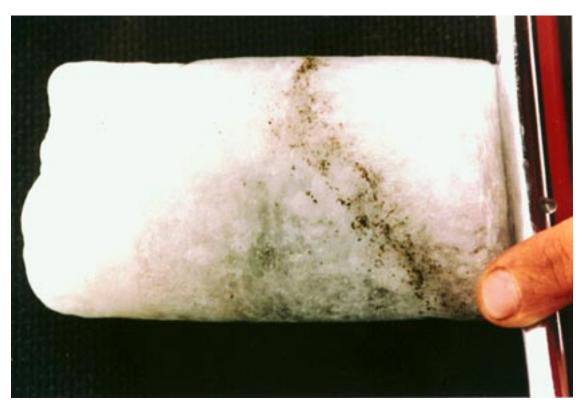
Figure 15. Mineral deposits in concentrated bands in ice.

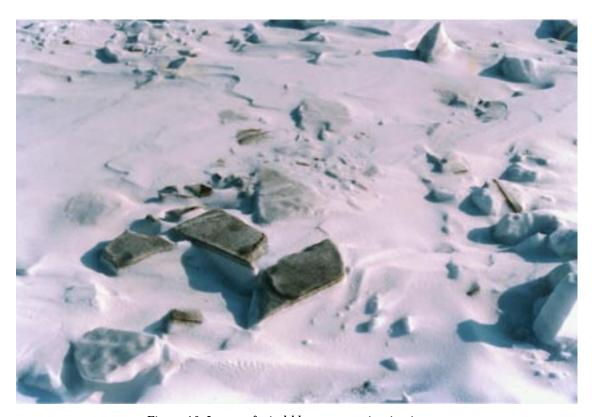
$Figure~16.~Layers~of~wind\mbox{-}blown~contamination~in~snow.$

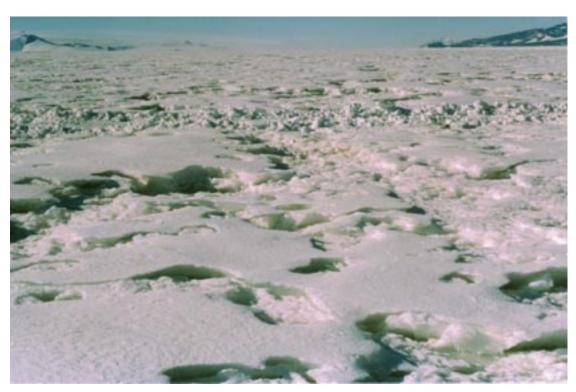
Figure 17. Rotted snow surface resulting from differential ablation brought on by localized concentrations of mineral particles deposited by wind.

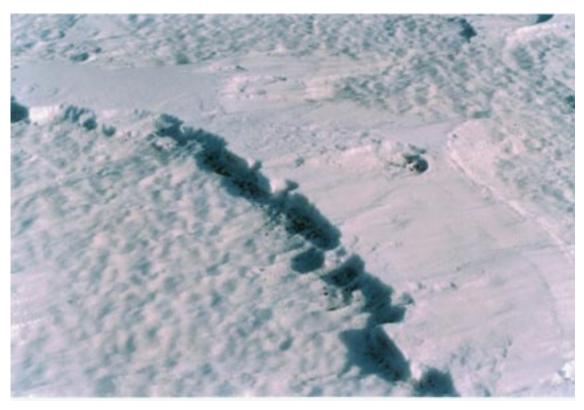
Figure 18. Moving sand trapped in sharp surface features on snow surface.

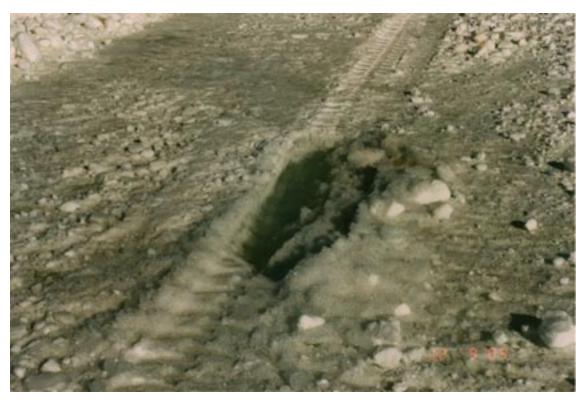
Figure 23. Grader tracks showing breakthrough of thin ice cover over subsurface melt pool.

Ice temperature profiles are the most important ice information because the mechanical behavior of ice subjected to loading is strongly influenced by its temperature. Vital information is the maximum temperature, particularly during the time period the runways would operate, and its location within the ice column. Subsurface melting may not always be obvious, but it could easily be disastrous for wheeled traffic (Fig. 23). If tem-

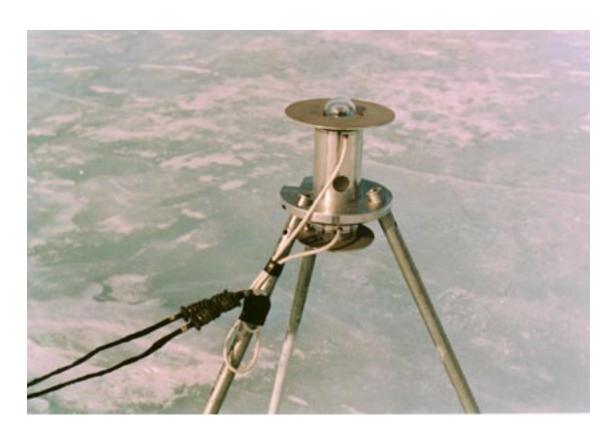
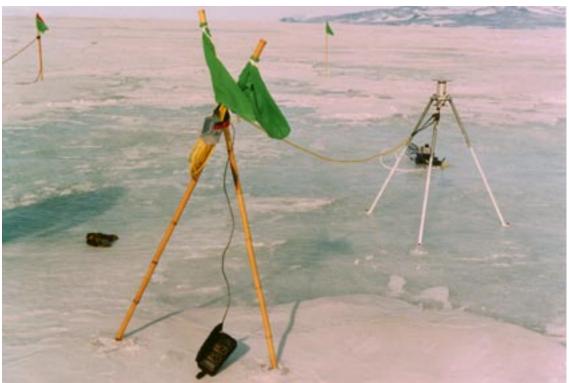
Figure 24. Radiometer pair used to measure albedo of snow and ice surfaces.

At the Pegasus site, we used Eppley pyranometers on several occasions during the peak of the austral summer. Unfortunately, we have never had the opportunity to connect them to a data acquisition system and thus only have spot readings. We used a tripod system for mounting the

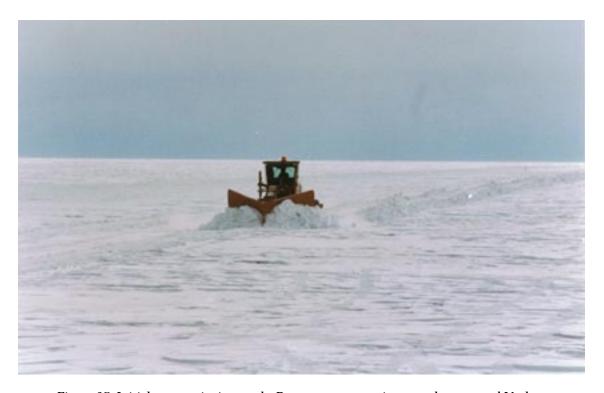
Figure 27. Initial snow stripping on the Pegasus runway using a grader-mounted V-plow.

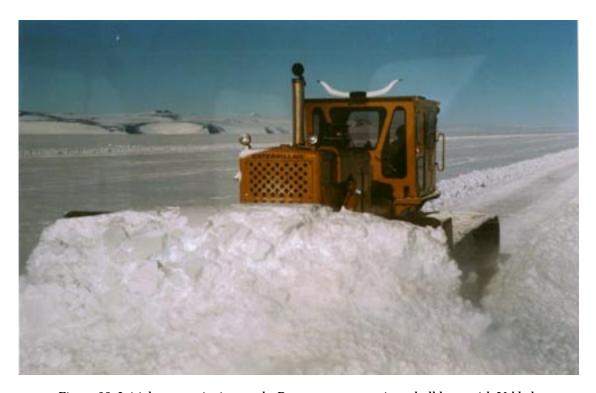
Figure 28. Initial snow stripping on the Pegasus runway using a bulldozer with U-blade.

We also used an elderly Caterpillar LGP D8 equipped with a Balderson coal U-blade to strip the snow from the glacial ice surface (Fig. 28). At first the bulldozer operator worked by "feel," attempting to hold the blade just at the snow/ice interface. Owing to the undulating ice surface and the need to provide some downforce on the blade to keep it from riding up in the snowpack, this often resulted in the blade gouging into the

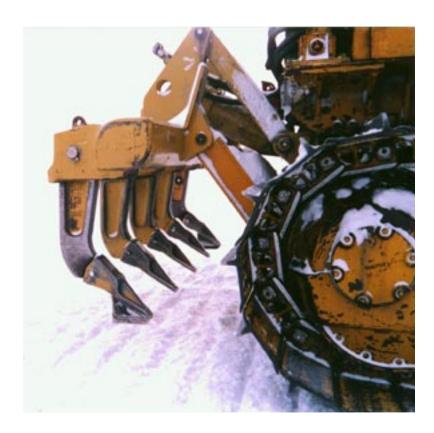
Figure 30. Ripper equipped with skids on outer teeth.

An attempt was made to strip the snow directly from the ice surface with the snowblower. The problem of ice gouging, as experienced with the blades, was also found to exist for the cutting edge of the blower. We equipped the blower with skids similar to those for the bulldozer blade, and

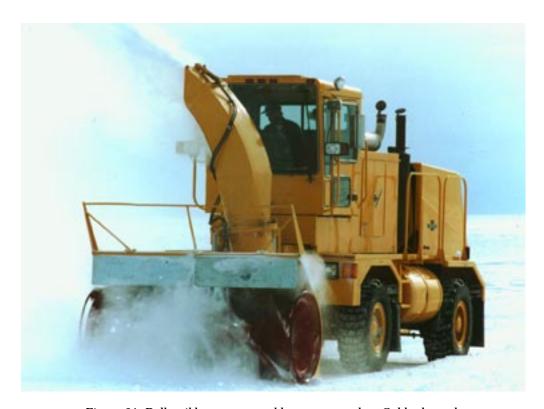
Figure~31.~Rolba~ribbon-type~snowblower~mounted~on~Oshkosh~truck.

To remove the snow from the runway area, we used an Oshkosh prime mover equipped with a Rolba snowblower (Fig. 31). The 2.6-m (8.5-ft)-wide, two-stage blower with a 1.5-m (4.8-ft)-diam. ribbon-style drum was mechanically driven (drive shaft). Separate motors powered the blower (300 kW or 400 hp) and the prime mover. The unit we used had four-wheel drive and four-wheel steering, the latter being unnecessary for our application. The blower was rated for 2720 tonnes/hr (3000 tons/hr) with a casting distance of 46 m (150 ft). The blower head was controllable for up and down (including down pressure), tilt forward and back, and casting direction (roughly 140° centered about the vertical with infinitely adjustable

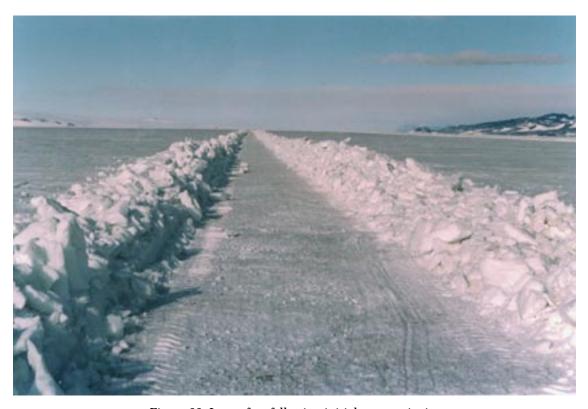
Figure 32. Ice surface following initial snow stripping.

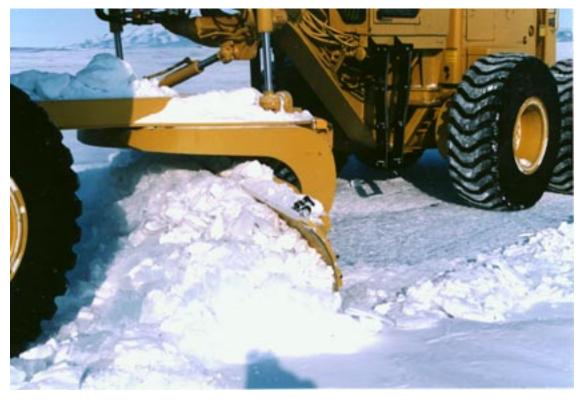
Figure 34. Aggressive grader blade removing up to 20 cm (8 in.) of glacial ice in one pass.

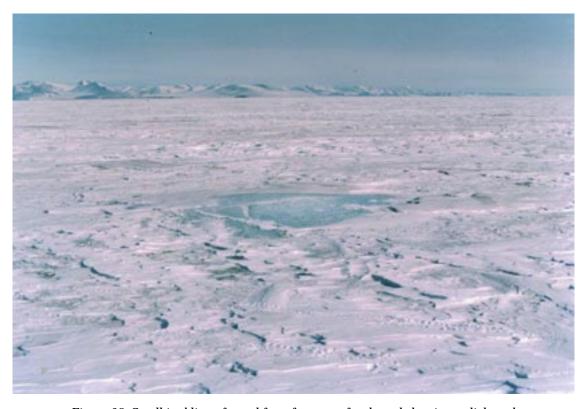
Figure 35. Small ice blister formed from freezeup of melt pool showing radial cracks.

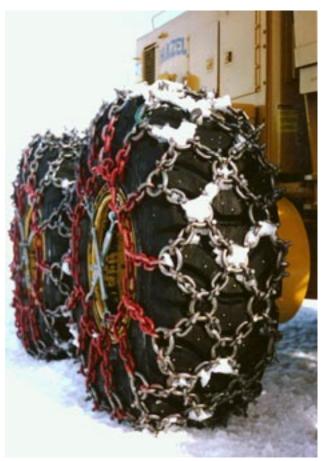
Figure 37. Aggressive tire chains as used in logging industry installed on motor grader to reduce slip during ice grading.

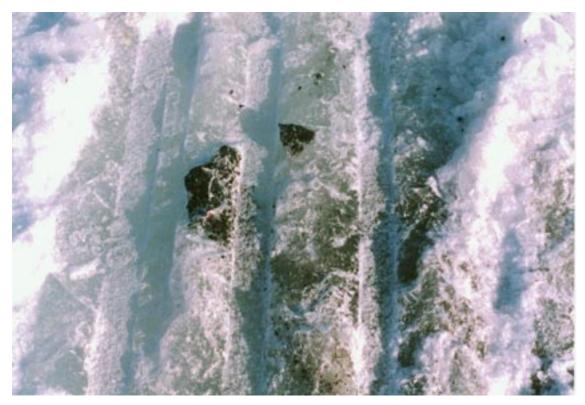
Figure 38. Mineral matter trapped in the ice.

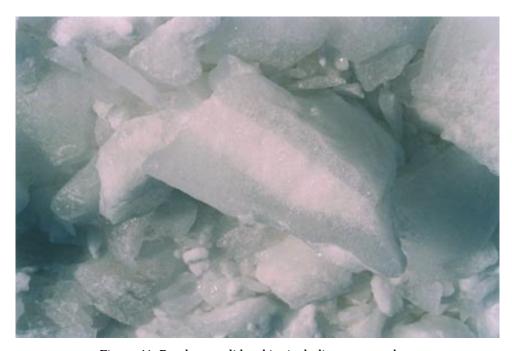
Figure 41. Poorly consolidated ice including snow pockets.

Following initial grading and debris removal, the runway should be carefully inspected and sampled to determine ice integrity, including the presence of cracks, variations in ice appearance or surface strength, potholes or other melt features, and to affirm the topography revealed from the initial survey data. Cores should be taken, especially in low spots, to determine how much ice might need to be graded to remove all porous or weak ice. This weak ice, which we called trash ice, is typically found in the shallow basins on the runway surface and often has large bubbles, incorporated lenses of snow, high concentrations of mineral particles, and occasionally is held together only with thin segments of ice plates (Fig. 41). The trash ice we discovered

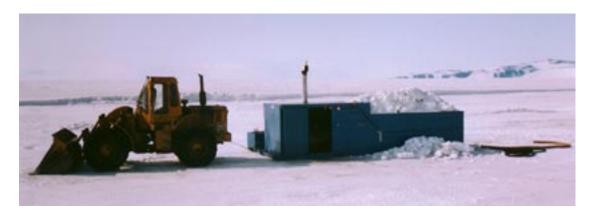
Figure 42. Portable snow melter.

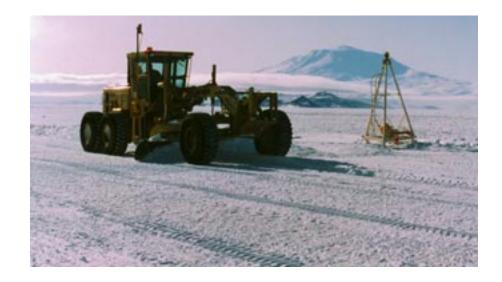
Figure 44. Motor grader under laser control during final grading of ice. Transmitter is mounted on robust, portable tower.

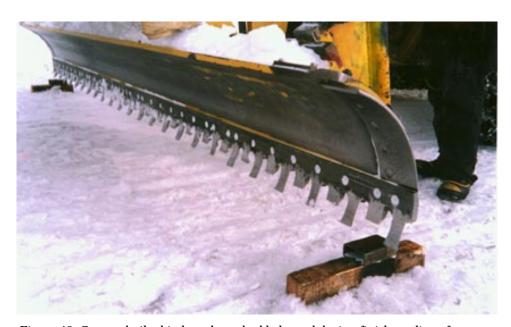
Figure 45. Custom built chisel-tooth grader blade used during finish grading of runway.

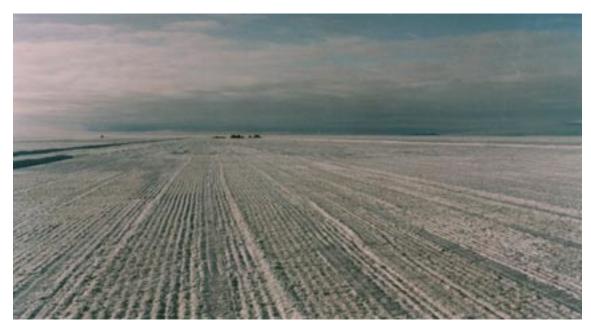
Figure 47. Finish-graded ice surface seen in foreground with rough graded segment of runway in background.

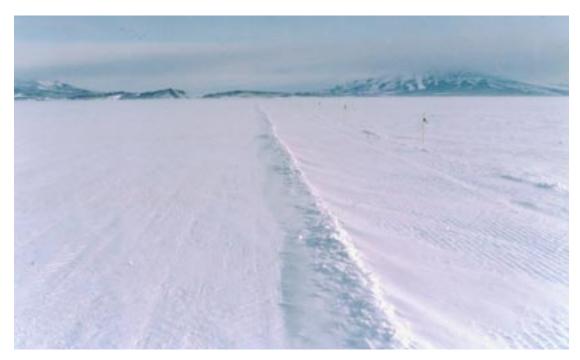
Figure 48. Small windrows trapping blowing snow.

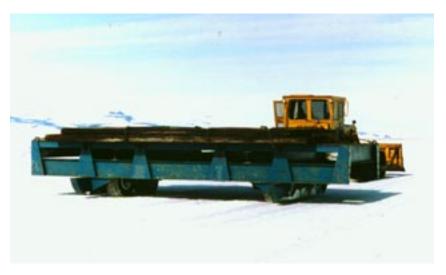
Figure 49. Cart for proof rolling the Pegasus runway shown configured for C-130 landing gear; ballast is steel plate.

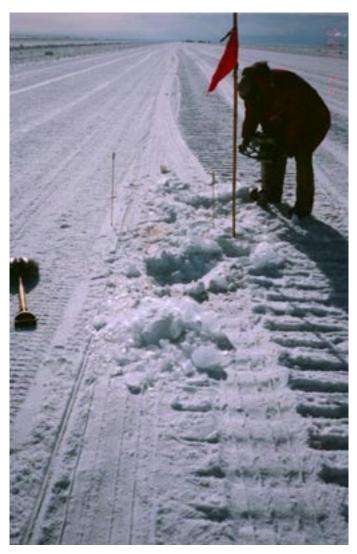
Figure 51. Site of failed runway ice caused by proof cart.

Approximately 30 weak spots were found by the proof roller. In these locations, the ice failed by crumbling, leaving a slight depression in the surface. Excavation of failed points revealed that they had an average size of 30 ft² (2.8 m²) and were 6–18 in. (15–46 cm) deep. In nearly every case, failure points were associated with a thin (0.25- to 0.5-in., 0.6- to 1.2-cm) gap. This gap was most likely caused during refreezing of meltpools that were known to have been present at this site during the 1991–92 summer season.

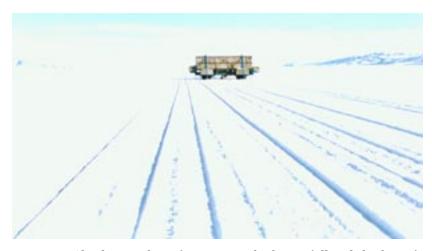
Figure 52. Closely spaced proof cart tire tracks during full-scale load certification of runway.

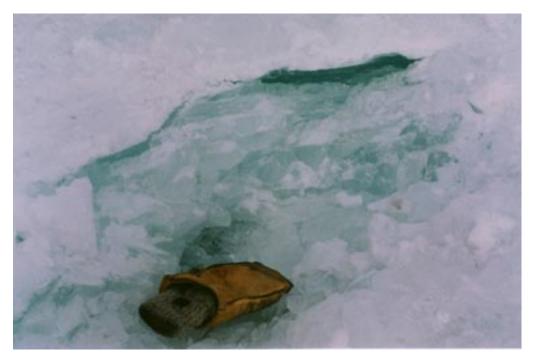
Figure 53. Failure planes in ice extending into sides of main cavity of failed area.

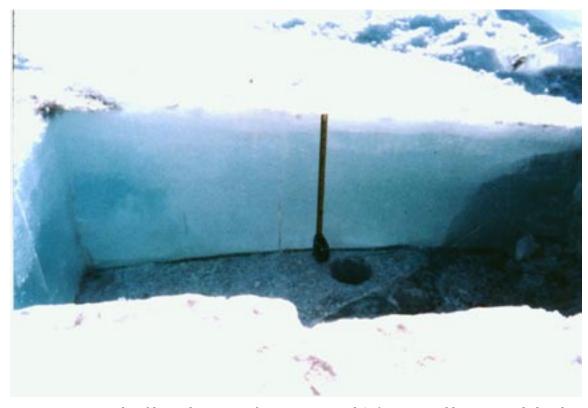
Figure 58. Dissected ice blister showing gap between upper melt/refreeze ice and lower natural glacial ice.

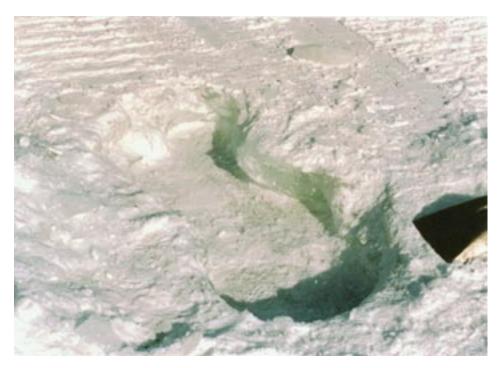
Figure 59. Ice failure site cleaned out and ready for patching.

Each failure point was excavated and all of the fractured ice around the edges was dislodged. The ice chunks were broken into fist-sized pieces and packed into the cavity. Cold water was then used to flood the cavity, making an ice bath that froze completely within 48 hours. Numerous patched spots were re-proof-tested and all were found to be sound. The runway was therefore certified for operation of wheeled Hercules aircraft.

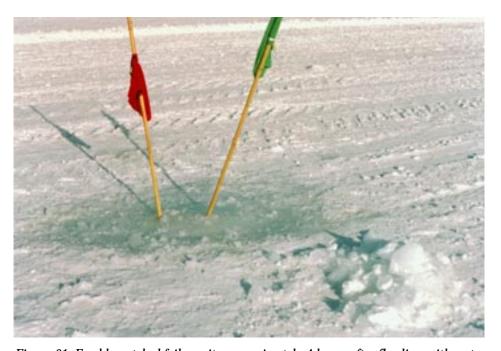
Figure 61. Freshly patched failure site approximately 4 hours after flooding with water.

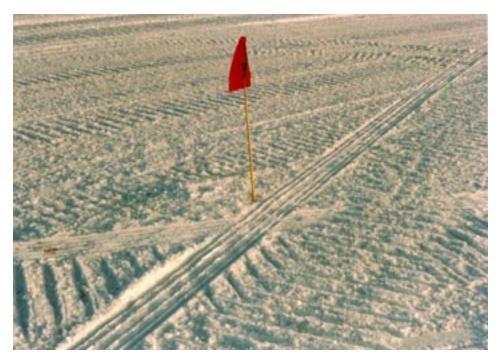
Figure 62. Tracks of proof cart on area patched 48 hours earlier.

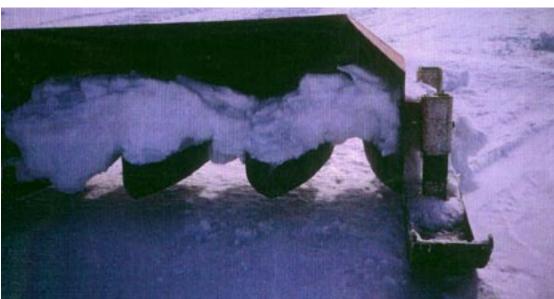
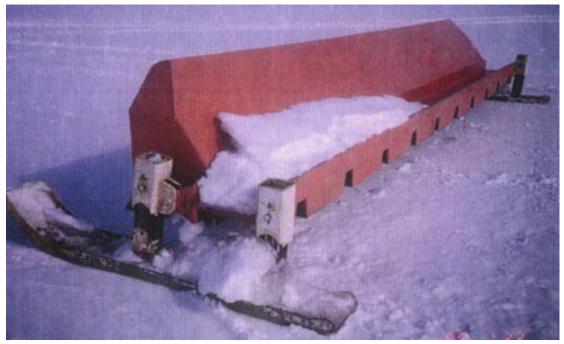
Figure 68. Windrow drag used to encourage snow accumulation.

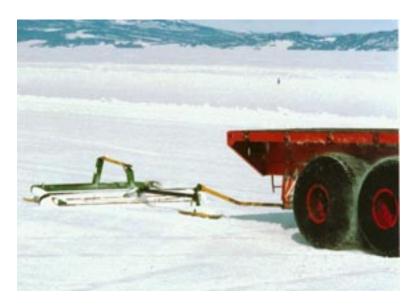
Figure 69. Small snow plane with minor height adjustability.

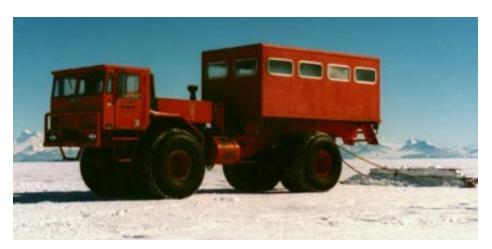
Figure 73. Drag made from heavy I-beam.
